February 26, 2018  
File: PU17212B

RE: **Final Summary Letter**  
Wallowa Street Block 2, Lots 1–18  
Sundance South Subdivision  
Pullman, WA 99163

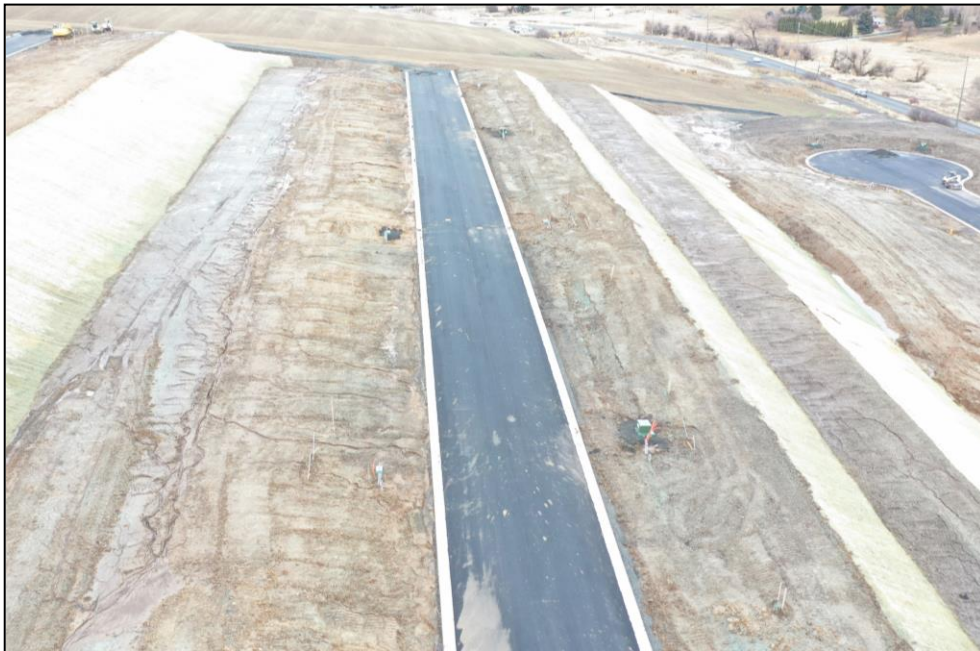
**Photograph 1: Wallowa Street**

This final letter is intended to summarize the major aspects of our CMT services associated with infrastructure construction along Wallowa Street. This summary does not describe the entirety of our scope and the details of our observations are not reproduced herein. These observations were previously transmitted to the project team and City of Pullman in weekly transmittals since project commencement and are included in the attached appendix. See the final construction in Photograph 1, below.

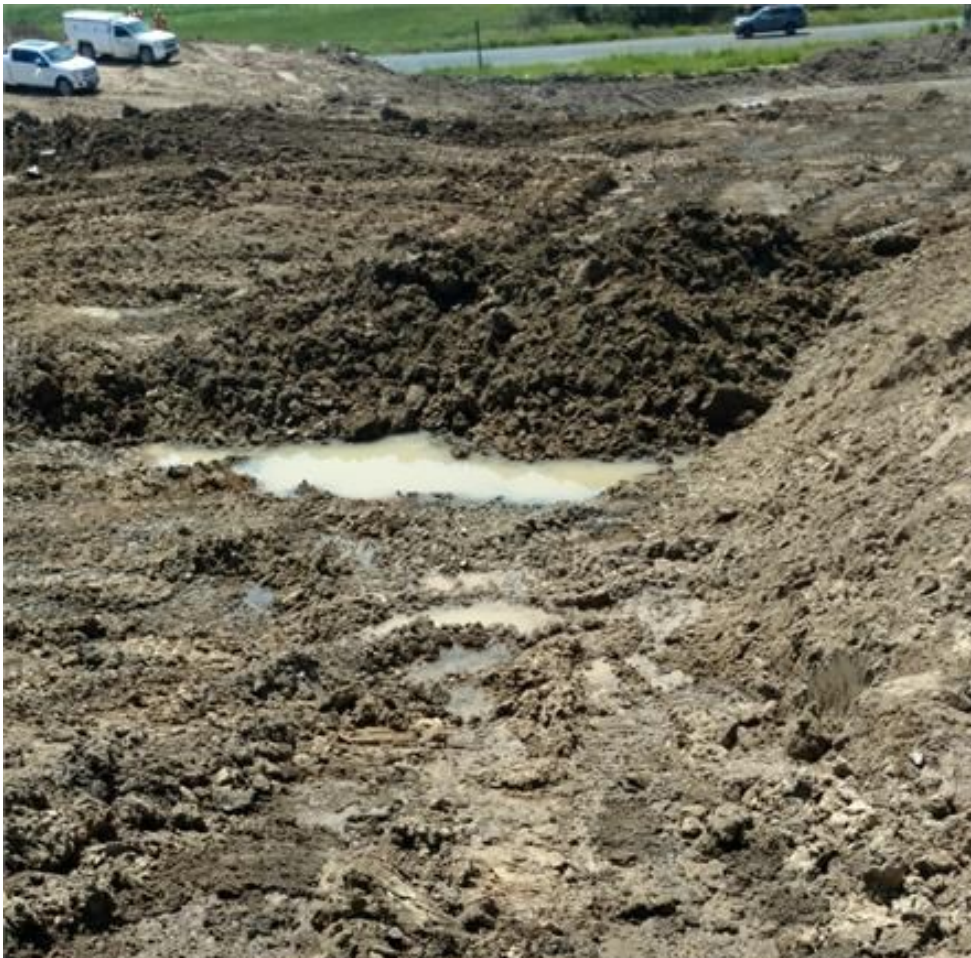
It is probable that water in the subgrade trench drain is mounded at its termination point and has enough head behind it that it is being forced down gradient through the soil matrix creating water pressures before eventually daylighting on the slope. These characteristics are problematic for both constructability and long-term performance. My recommendation is that the area be sub excavated and allowed to daylight such that the water can freely flow. This sub excavation will probably measure several hundred cubic yards 4 to 6-feet deep and will need to be backfilled with the drilled and blasted shot rock generated immediately below or an alternative source. Alternatively, the trench drain could be located and extended down along the lot lines to the next downgradient stormwater connection or to the pond. At any rate, my recommendation is this work advance as early as next week to allow construction to proactively continue and to reduce the hazard of instability both short and long term. This lot or 2 will not be suitable for eventual development without implementing some remedy.

**Discrepancy Description:** Water daylighting from the slope face.

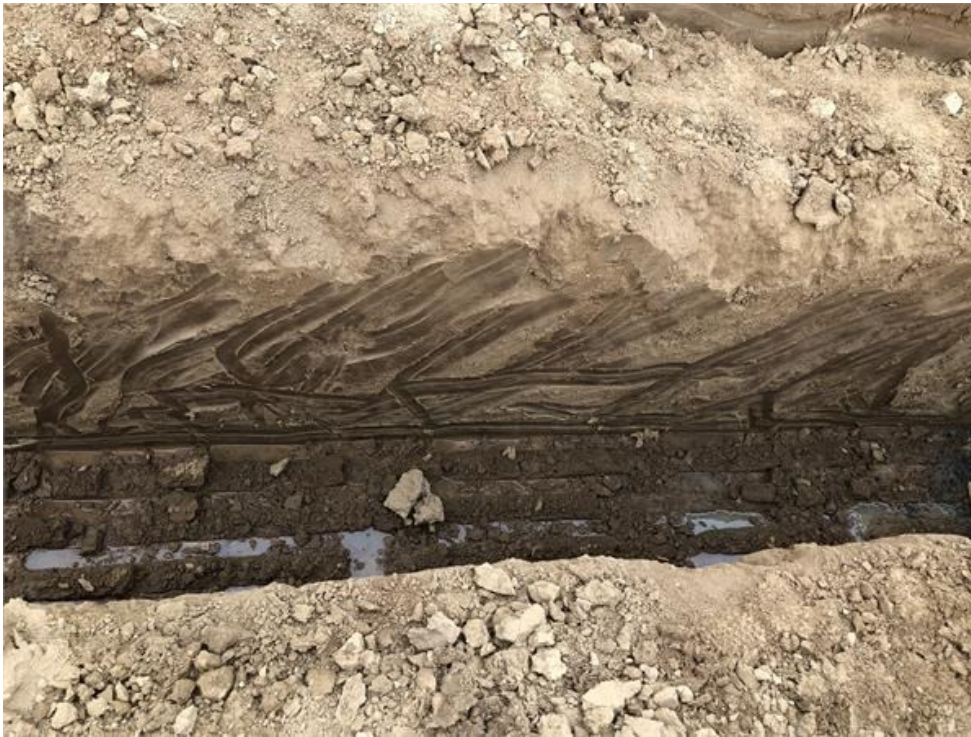
**Upload Description:**  
15' north of Wallowa St. on Golden Hills Dr.

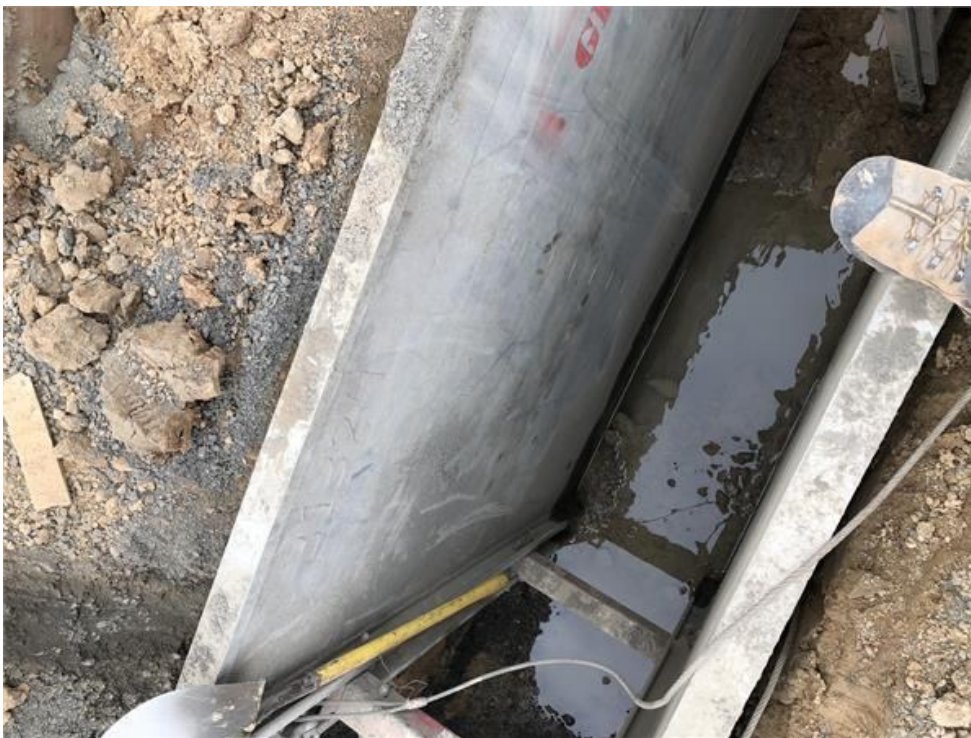
**Upload Description:**  
5' north of Wallowa St. on Golden Hills Dr.

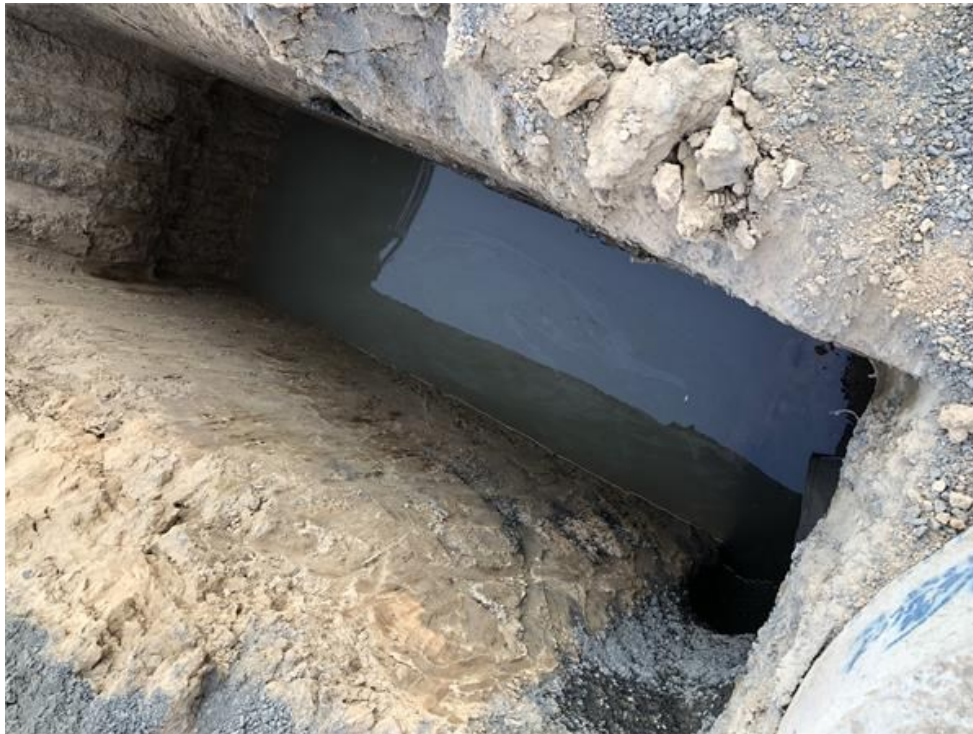
Ground water run collecting in storm drain trench at Wallowa Street and Golden Hills Drive
