July 19, 2019 File: PU17212B

**RE:** Final Summary Letter

Umatilla Court Block 1, Lots 1 - 15 Sundance South Subdivision Pullman, WA 99163

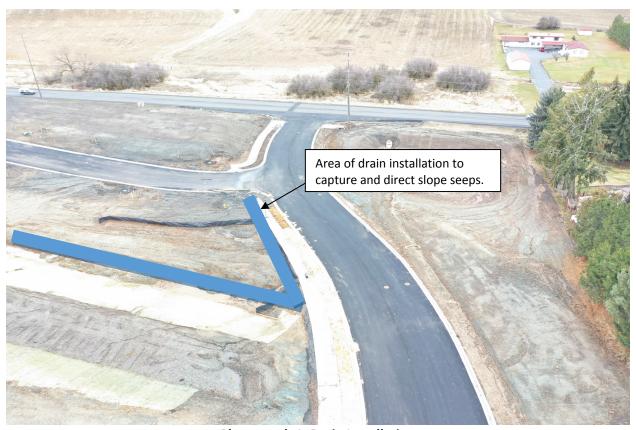
The upslope subsurface drain design was not planned to extend this far south on the project due to storm sewer connectivity issues. Therefore, GPI recommended the drain either extend through this area, or multiple additional drains traverse east to west, near norther lot lines (lots 13 through 15), and through any area that exhibits consistent seepage on or near the crest or base of these constructed slopes. Through our interactions with you and the City of Pullman, you elected to construct drains in accordance with recommendations from GPI, along the north side of lots 13 through 15. Drains were subsequently installed, slopes regraded and seepage appears controlled at this time. Drain construction was witnessed by GPI between July 10 and 15, 2019.

**Photograph 1: Drain Installation**

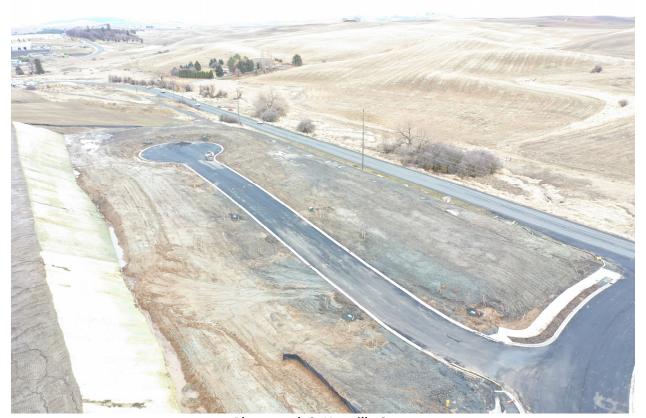
Photograph 2: Umatilla Court

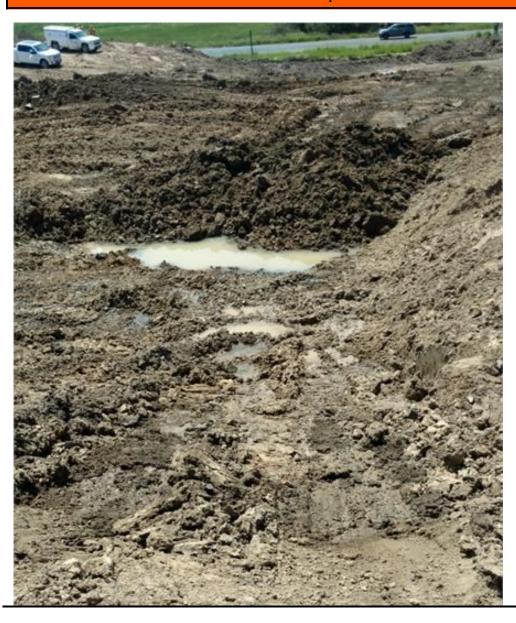
It is probable that water in the subgrade trench drain is mounded at its termination point and has enough head behind it that it is being forced down gradient through the soil matrix creating water pressures before eventually daylighting on the slope. These characteristics are problematic for both constructability and long-term performance. My recommendation is that the area be sub excavated and allowed to daylight such that the water can freely flow. This sub excavation will probably measure several hundred cubic yards 4 to 6-feet deep and will need to be backfilled with the drilled and blasted shot rock generated immediately below or an alternative source. Alternatively, the trench drain could be located and extended down along the lot lines to the next downgradient stormwater connection or to the pond. At any rate, my recommendation is this work advance as early as next week to allow construction to proactively continue and to reduce the hazard of instability both short and long term. This lot or 2 will not be suitable for eventual development without implementing some remedy.

Discrepancy Description: Water daylighting from the slope face.

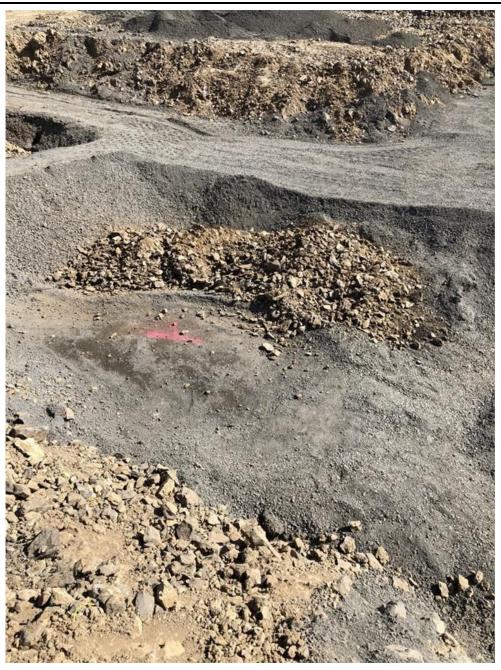
Material to coarse for testing placed in between storm drain piping and sanitation piping from manhole 7 to 6

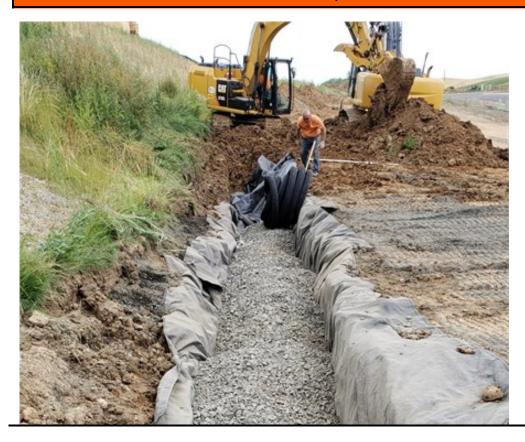
I arrived on site and observed the drain excavation which was approaching the 3rd and final lot. The drain was excavated to the bedrock surface which varied from about 4 to 5 feet below the surface. Geotextile fabric was placed along with a perforated ADS pipe. Drain rock surrounded the pipe up to 1 foot from the surface, leaving enough fabric to overlap the rock. The adjacent slope was slightly undercut in this process and I noted to Fred that it would need to be graded back to avoid reducing the slope support. Fred noted the area in front of the drain was going to be cut down and would facilitate this grading process. I expect the drain will be complete today and grading will commence tomorrow. It appears this aspect of construction will be complete by midweek.
